**PROPERTY INSPECTION REPORT**

**Prepared For:** Client A  
(Name of Client)

**Concerning:** 123 ABC Street Houston, Texas  
(Address or Other Identification of Inspected Property)

**By:** Fred Willcox Professional Inspector #160 2011  
(Name and License Number of Inspector) (Date)

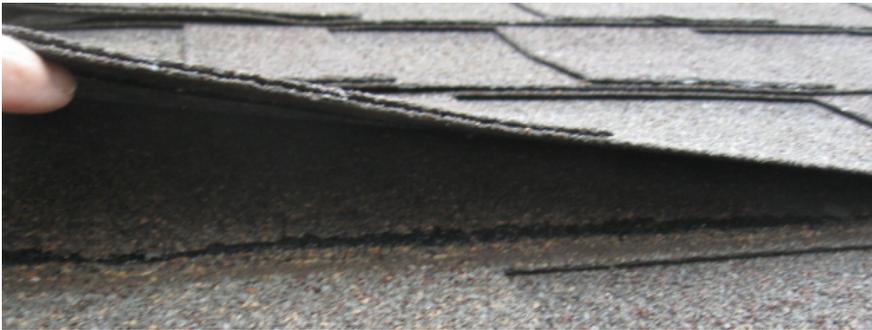
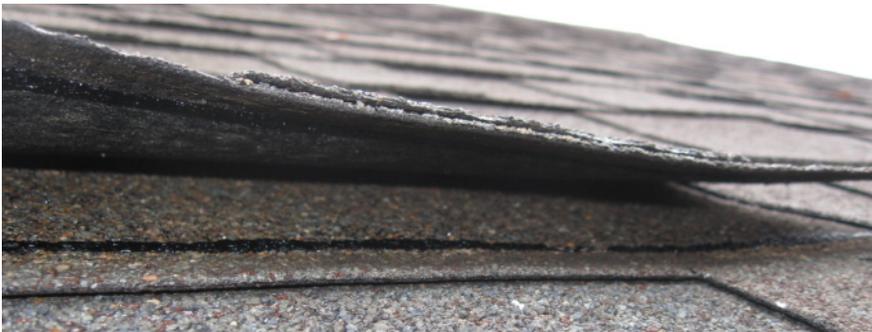
**Deficiency: Some of the shingles had not bonded or sealed to each other.**

Information: These shingle tabs could be lifted by hand. An adhesive strip is manufactured into each shingle. The adhesive is softened by the heat of the sun and bonds to the shingle below. Some manufacturers contend that the bonding or sealing of the shingles to each other is more important than the location of the fasteners in securing the shingles to the roof deck. Failure of the shingles to bond makes it far more likely that the shingles will be stripped off the roof when the roof covering material is subjected to high wind loads. Failure of the shingles to bond or seal is often an indication of a manufacturer's defect. The manufacture should be contacted for recommendations on the replacement of the shingles or for the application of an adhesive to seal the shingles.

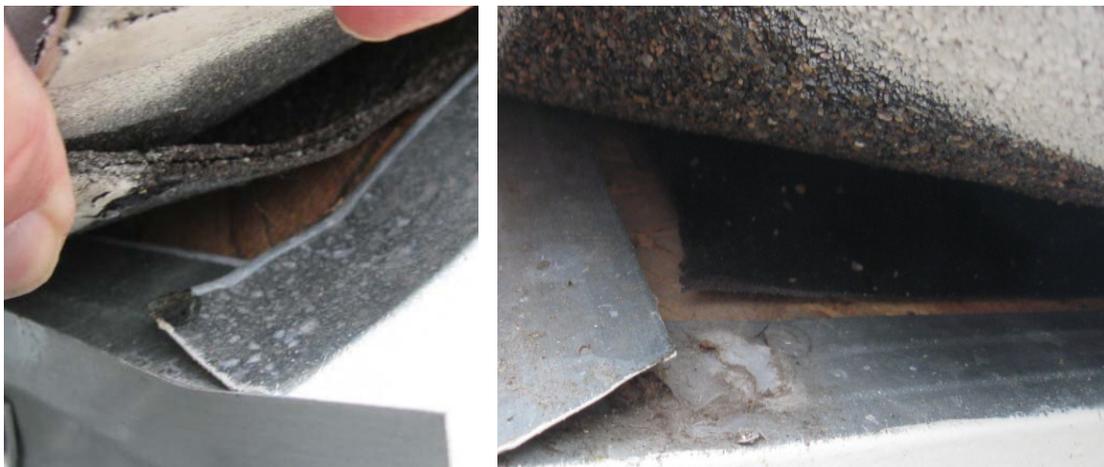
**Deficiency:** Some of the discharge ends of the side wall flashing material terminated under the shingles.

Information: The discharge ends must terminate on top of the shingles to prevent water from being directed onto the roofing felt. The flashing material should be properly terminated.

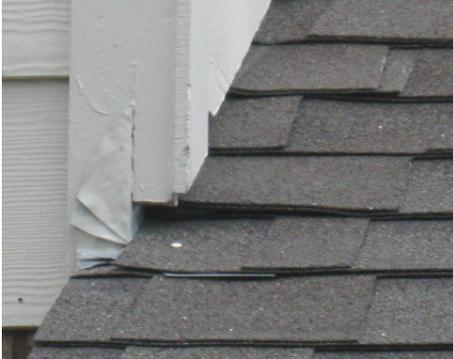
**Deficiency: There was a partial dead valley over the front entry area.**

Information: A dead valley is a valley that terminates against a wall and causes water to collect. The collection of water can be deep enough to defeat the flashing system which will result in leaks. As water collects, the load on the roof deck increases causing the roof deck to sag. The more the roof sags, the more water collects. The collection and weight of the water can cause flashing materials and/or the valley system to separate which would allow water to penetrate the roof covering system and enter the structure. In this case, the J flashing was raised creating an obstruction to the flow of water. In addition to restraining the flow of water, the J flashing installation has caused the shingles to deform. The deformation of the shingles can cause the shingles to crack and break. A qualified, skilled roofer should be engaged to closely examine this area to determine that the roof covering materials are properly flashed and sealed to prevent future leaks.

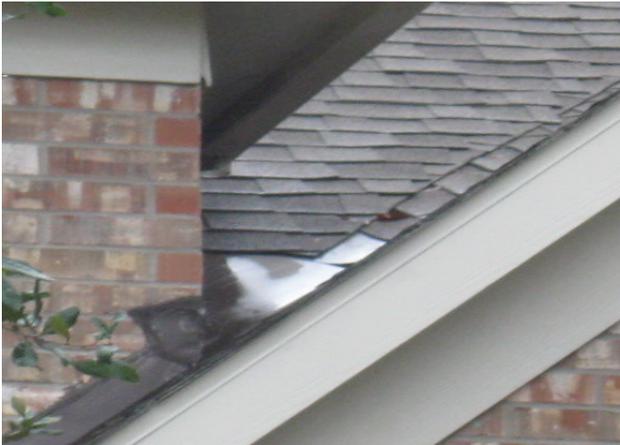
**Deficiency: There were no flashing materials installed at the junctions of the roof surfaces with the exterior walls at some of the extensions of the roof deck around the corners of the walls.**

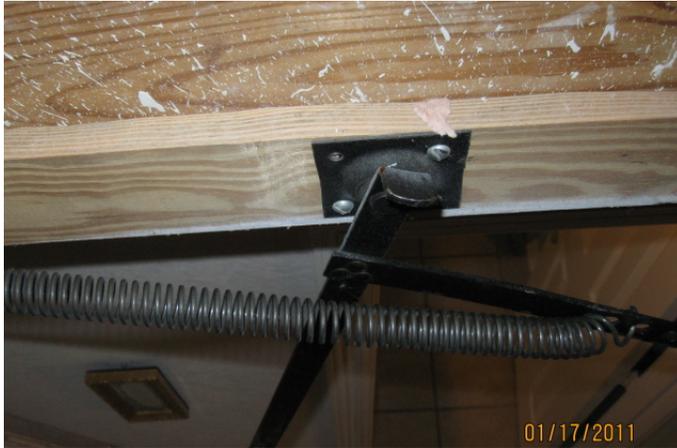
Information: The springs did not catch on the hinge arms making the ladder difficult to close. The door springs should be adjusted so that the unit can be closed properly.

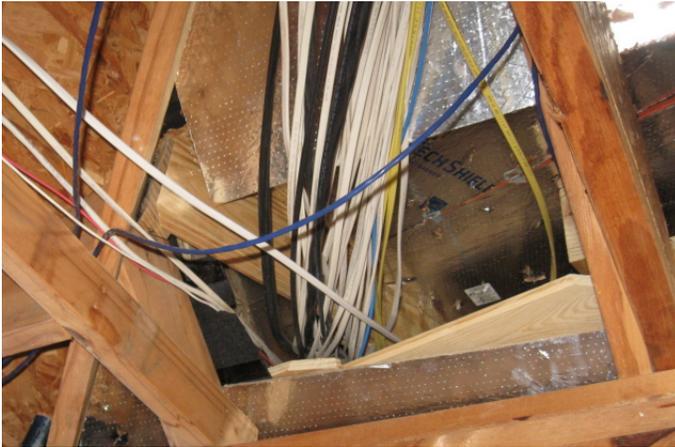
**Deficiency:** There was no firestop at the entrance of the breezeway in the garage.

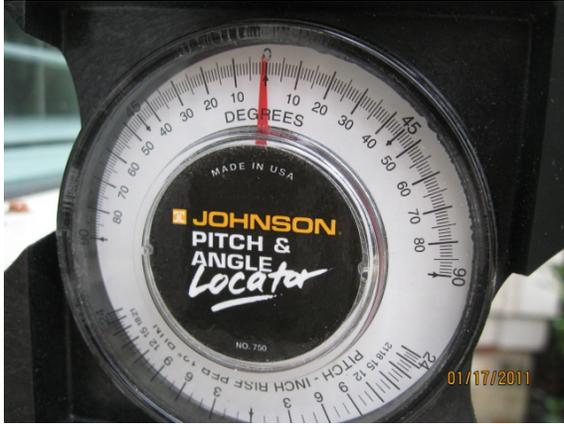
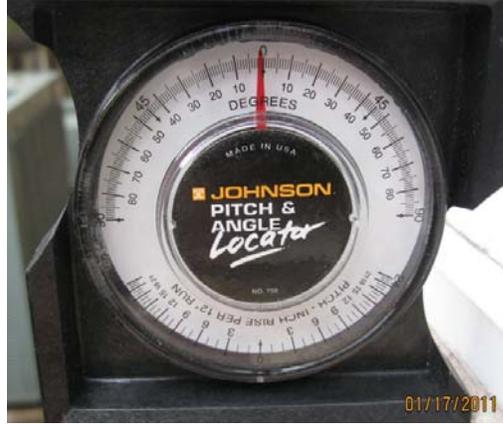
**Deficiency:** The brick window ledgers were improperly or inadequately sloped at some of the window penetrations.

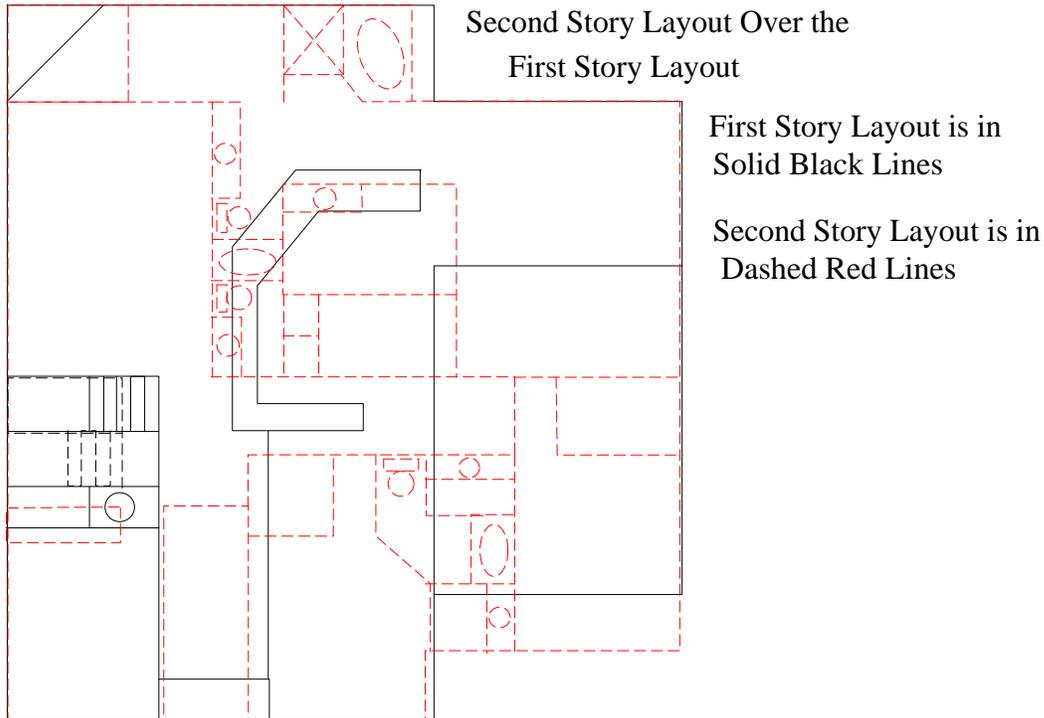
**Deficiency: Floor slopes in excess of or different from the deflections noted in the first floor elevations were found in the second story floor framing. As shown in the drawings below the second story interior walls are not all over the first floor walls. This configuration appeared to be a cause of some of the deflections.**

As the floor framing system of this house did not appear to have been overloaded, the presence of the excessive deformations of the floor framing systems indicates that the causes of the deformations should be determined and corrected. The floor framing system should be analyzed by a competent structural engineer who is not routinely hired or employed by the builder of the house to remove any conflict of interest concerns.

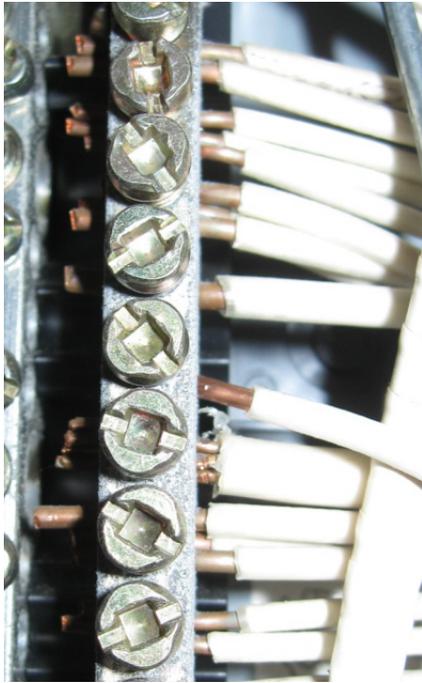
**Deficiency: Multiple grounded (neutral) conductors were connected under one screw on the bus bars.**

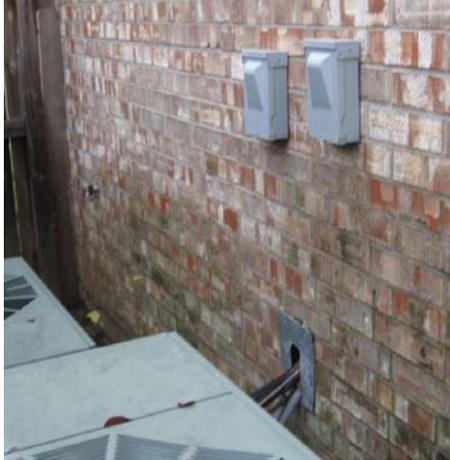
**Deficiency:** There was inadequate clearance in front of the air conditioning mechanic's disconnects at the air conditioning condensing units.

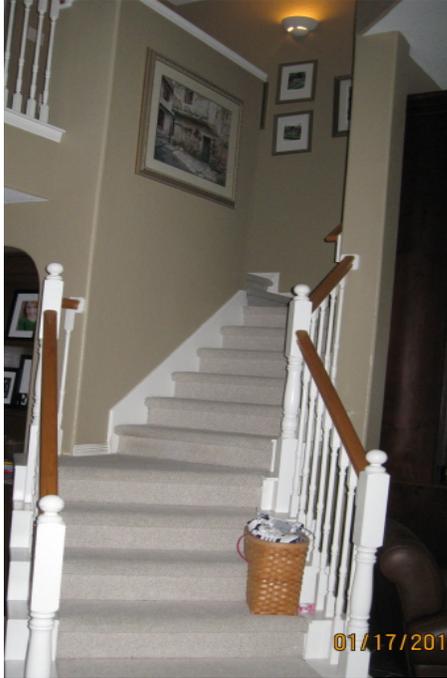
**Deficiency:** Some of the lighting fixtures such as the lighting fixtures in the master bathroom, upstairs and lighting fixtures on the exterior of the house, etc. did not operate.

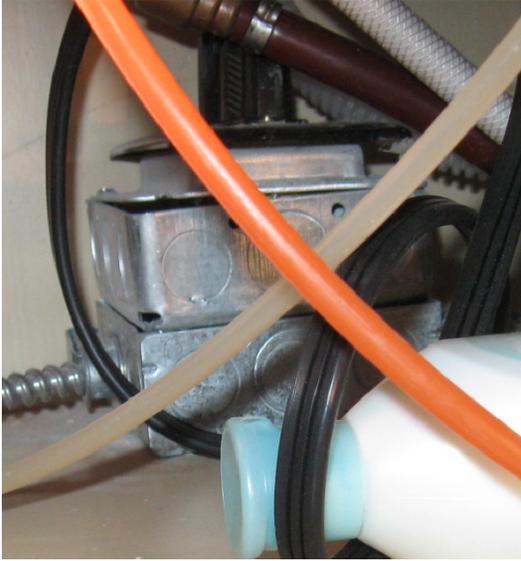
**Deficiency:** The electrical wall outlet for the master bathroom east side lavatory was improperly located too far away from the lavatory.

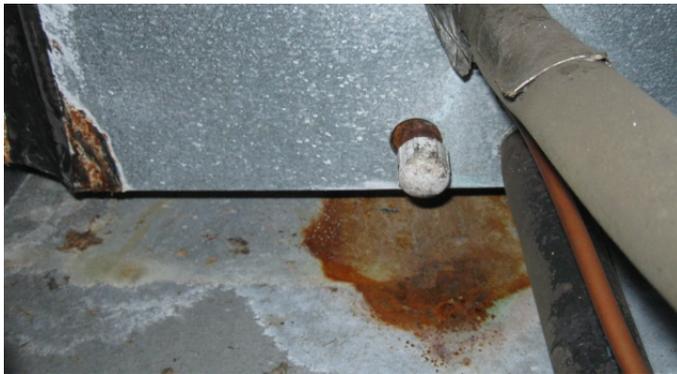
**Deficiency:** Water stains were noted in the safety pan of the east evaporator coil in the attic indicating that the evaporator coil's primary drain pipe had been, and may still be, blocked.

**Information:** The evaporator coil should be cleaned, checked, serviced and certified as being in good condition. Often HVAC technicians simply open the primary drain pipe without cleaning the evaporator coil. Simply opening the drain pipe without cleaning the coil will cause the drain to become block again in the near future.

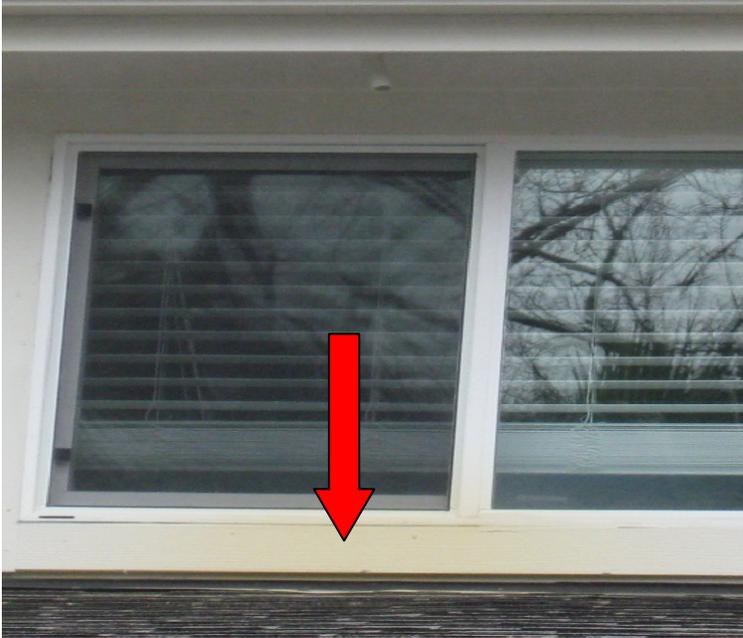
**Deficiency:** There was evidence that the safety pan(s) had over flown in the past.

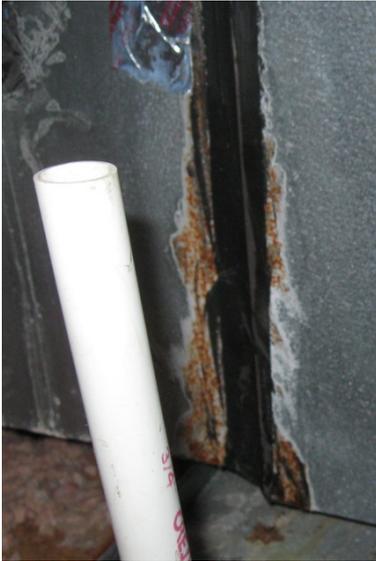
**Deficiency:** There were stains from condensation on the exterior of the east evaporator coil and plenum.

**Information:** Condensation on the exterior of the coil casing can cause the casing to rust and damage which would render the coil inefficient if not useless. The cause(s) of the condensation should be determined and eliminated.

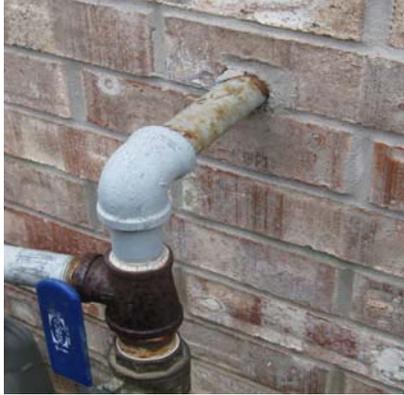
**Deficiency:** The natural gas pipe supply pipe penetration through the brick veneer is required to be sleeved so that no friction between the brick veneer and the gas pipe can develop and so that corrosives from the brick veneer cannot attack the gas pipe.
