**PROPERTY INSPECTION REPORT**

**Prepared For:** Client A  
(Name of Client)

**Concerning:** 123 ABC Street Houston, Texas  
(Address or Other Identification of Inspected Property)

**By:** Fred Willcox Professional Inspector #160 2011  
(Name and License Number of Inspector) (Date)

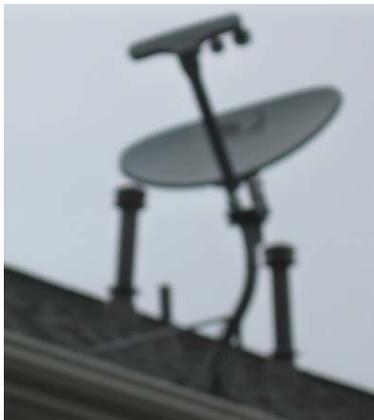
**Deficiency:** The dish for the satellite antenna system had been bolted to the roof deck through the shingles.

**Information:** There was no attempt to make the junction of the bracket with the shingles or the penetrations of the bolts through the shingles water proof. The bracket junction and the bolt penetrations should be made water proof or the dish should be removed from the surface of the roof. If the dish is removed, the damaged shingles should be replaced.

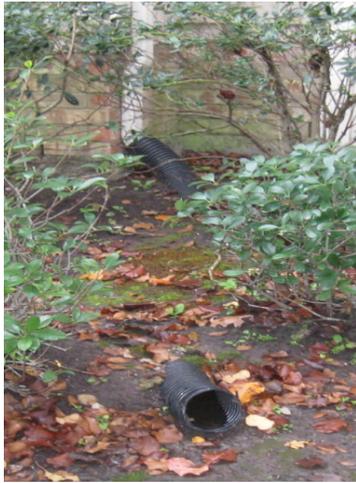
**Deficiency:** There were extensions on the downspouts that held water.

Information: These flexible extension pipes are used to extend the discharge of the water from the gutters out of the flower beds to reduce the erosion of the soils in the beds. These extension pipes must pitch downward to drain completely. Water held in the drain pipe extensions can allow the growth of microbial organisms and provide a breeding ground for insects and pests.

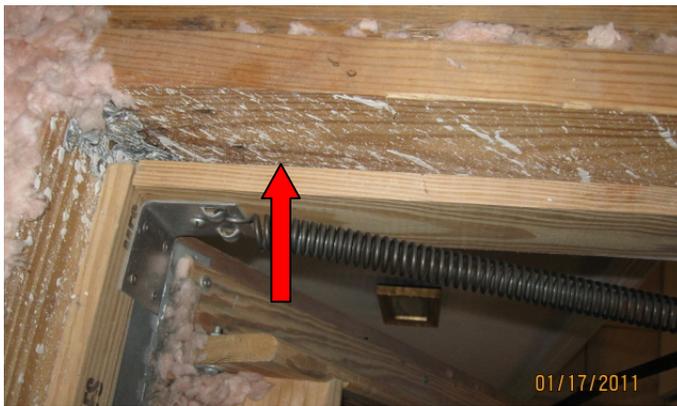
**Deficiency:** There was no firestop at the entrance of the breezeway in the garage.

**Information:** A fire stop is required at this location so that if a fire starts in the garage, the fire cannot immediately transfer through the breezeway into the house. As your builder located the electrical wiring so that it ran through the breezeway, no effective fire stop can be installed. A heat alarm, connected to your main alarm system, should be installed in the garage so that if a fire starts in the garage, you and your family will at least have the opportunity to escape from the house. For further information, see Sections R309.2, R602.8, E3302.2 and E3302.3 of the IRC (International Residential Code).

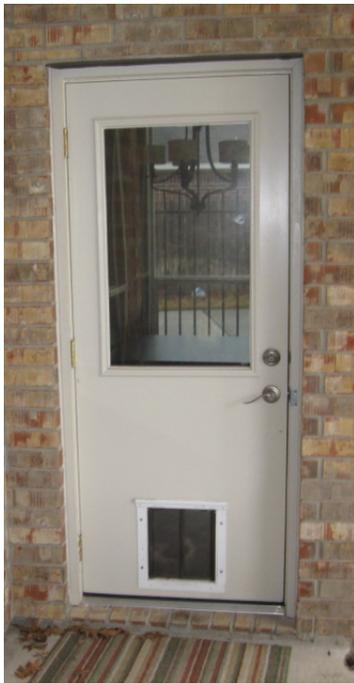
**Deficiency: The breakfast room exterior door was installed with the hinges on the exterior of the house.**

Information: Access to the house can be gained by removing the hinge pins. The door frame should be removed and properly reinstalled. It is also possible to installed locking or exterior hinges that would prevent the removal of the hinge pins or that would lock the door in the door frame if the hinge pins were removed. If this option is chosen, a plate should be installed to cover the lock throws so that the lock throws cannot be pried open.

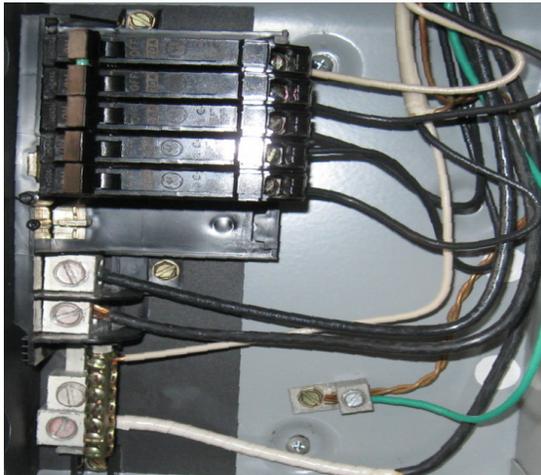
**Deficiency:** The circuits were not properly labeled or identified in the breaker panel.

**Information:** As the circuits were not identified, it could not be determined if the circuits were properly sized for the listed appliances. Over sizing of overcurrent protective devices on any appliance is a recognized fire hazard. Undersizing of conductors is also a fire hazard. The National Electric Code, Section 408.4, states that identifying circuits as 'bedrooms or wall outlets or light switches' is not adequate. Labeling must be specific as to which appliances are to be protected by the over current device. The circuits

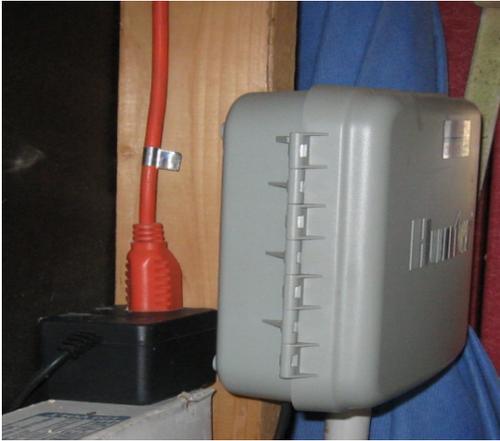
**Deficiency:** Extension cords were used as permanent conductors in the garage.

Information: Extension cords are not intended for permanent use and are not sized or insulated for such use. Prolonged and permanent use of extension cords is considered to be a fire hazard. The extension cords should be replaced with permanent wiring.
